## Arcus GIBB (PTY) LTD

# Environmental Impact Assessment for the Establishment of the Caledon Wind Farm, Western Cape Province

## Environmental Scoping Report Geotechnical Assessment

Date: November 2009

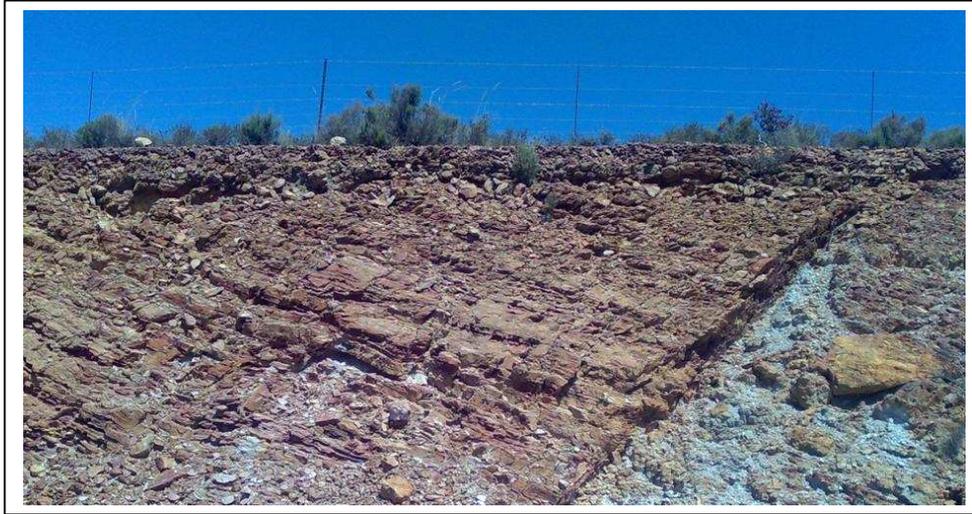
Figure 1 Exposure of interbedded siltstones, mudstones and sandstones of Bokkeveld Formation.

The area is underlain by interbedded siltstones, shales, mudstones and fine sandstones of the Klipbokkop Formation and Wagensdrift Formation of the Devonian age Bokkeveld Formation. The rocks are folded into a broad syncline which produces a topography consisting of ridges and valleys. The tops of the ridges are formed by a hard resistant sandstone layer. The rocks dip at approximately 25 degrees along a regional developed south-west north-east strike.

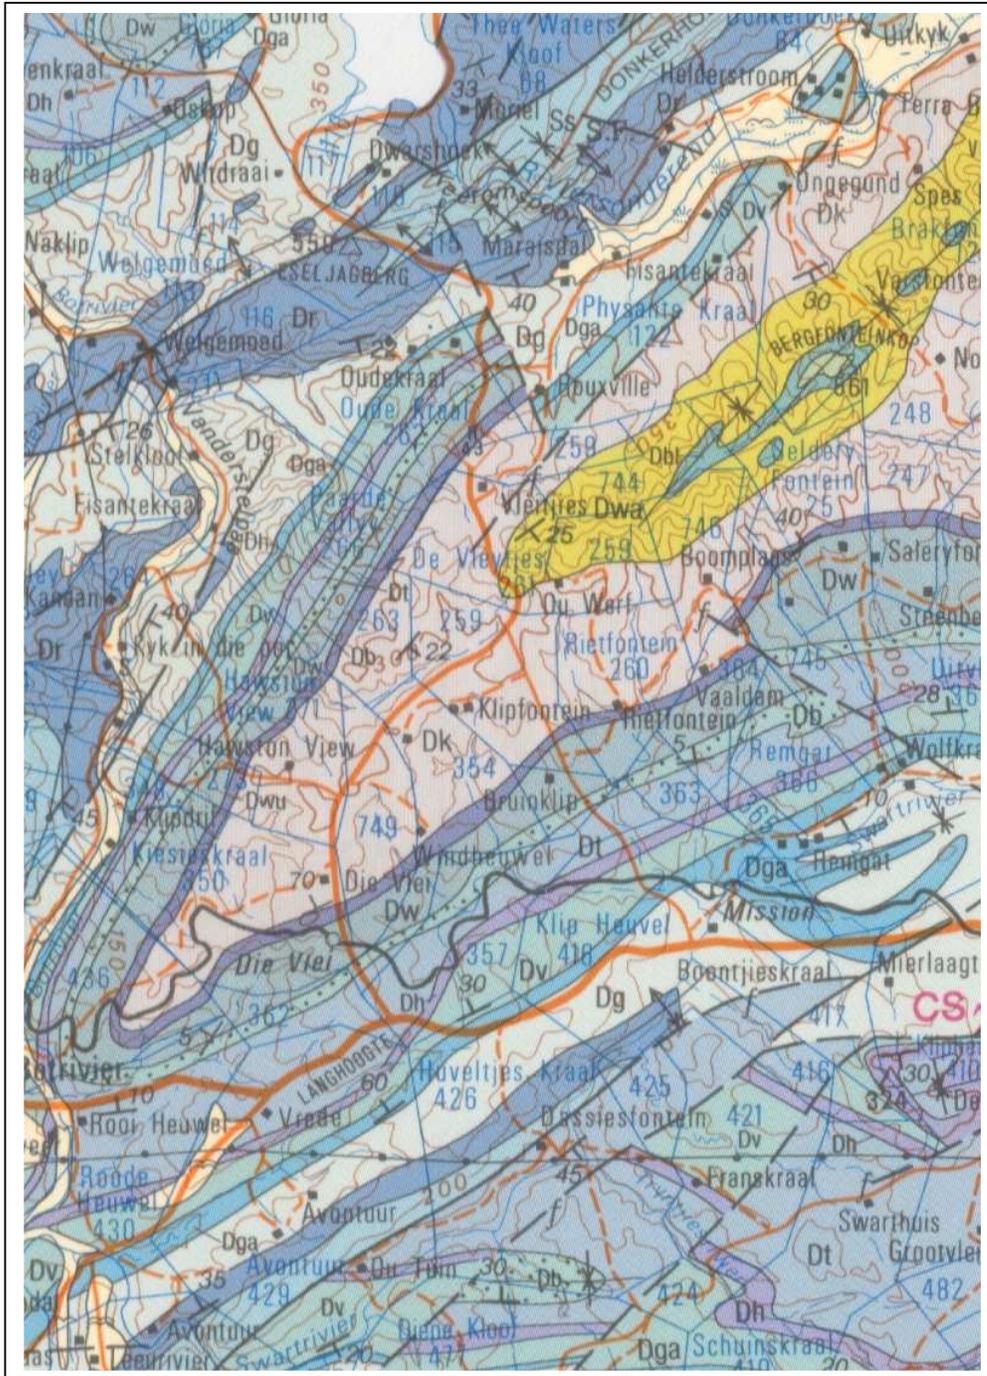
Figure 1 : 1:25 000 Geological Series (1997) Regional Geology of the Caledon Wind Farm area. Dwa- Wagen Drift Formation, Dk – Klipbakkop Formation.

The regional geology is part of the Cape Fold Belt. The area lies between two major fault zones which define the Botrivier valley which has formed along the south-west-north-east upthrown block of Bokkeveld shales and is bounded by the more resistant quartzite sandstones of the mountain-forming Table Mountain Group. This fault bounded valley provides an important topographic depression that controls wind direction and wind speed in the area.

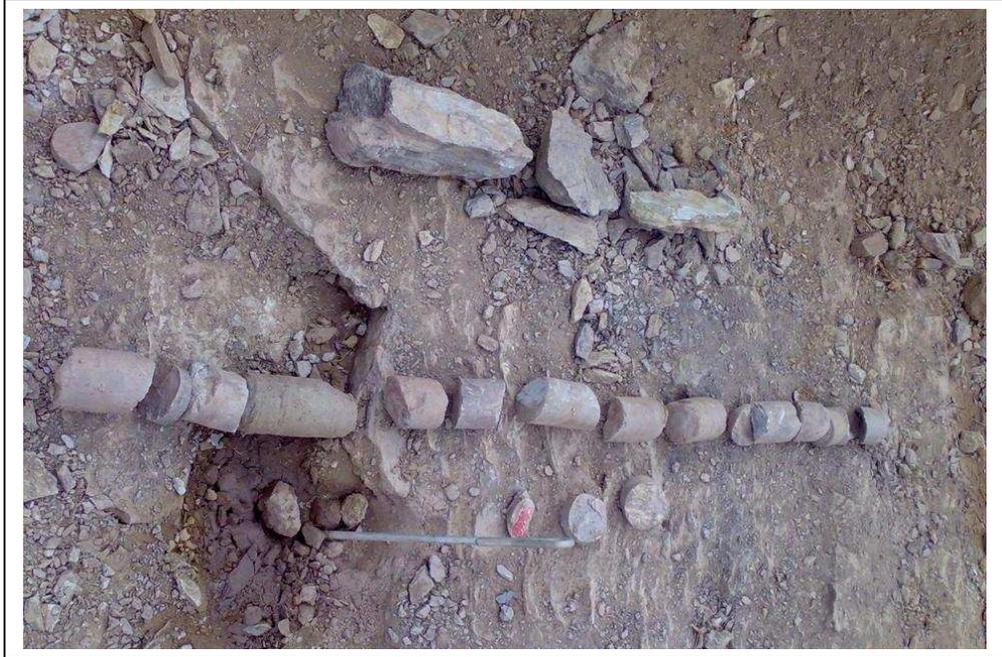
Figure 3: Intact rock condition encountered in trial drilling of a siliceous mudstone.

The 'soft to intermediate' rock condition in this area is considered highly favourable for founding the masts. In general founding depth would be approximately 1.9m, which corresponds closely to the expected depth of excavation possible in the rock without the need for rock blasting. The bearing capacity in the fractured shales is estimated to be at least 500 kPa which is double the required bearing capacity for the anticipated loads of the operating wind turbines. If the rock condition at the bottom of the excavation is highly uneven rock dowels can be used to prevent sliding of the concrete base. After casting the foundation area is backfilled with compacted rock and soil to a level of 0.95m above the concrete foundation and flush with the base.

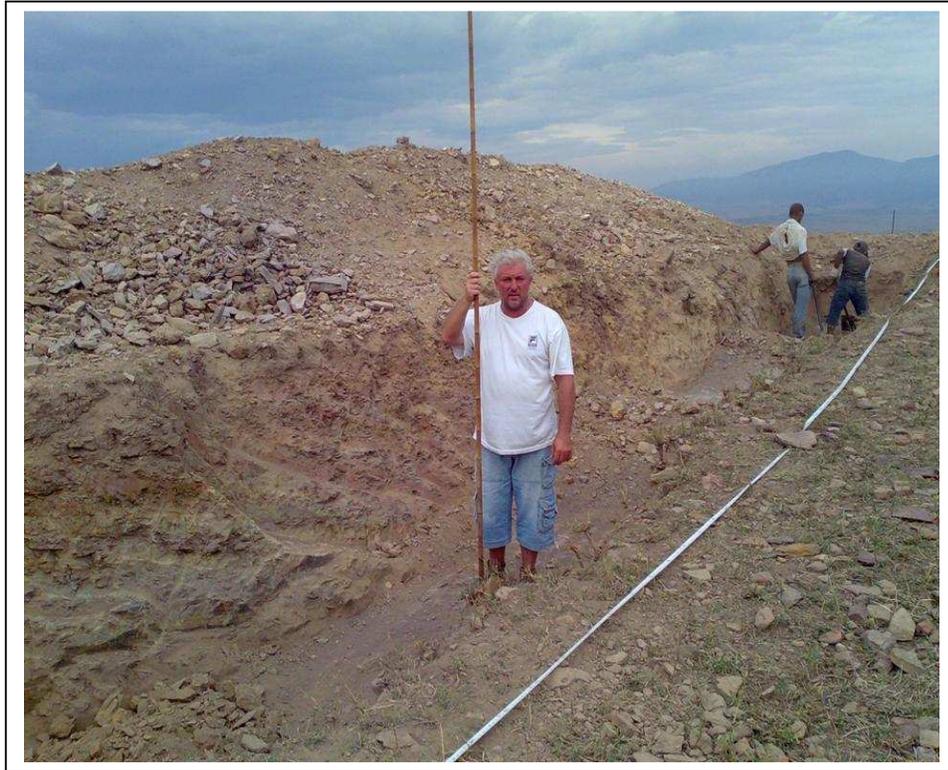
Figure 4 : Trenching conditions in Bokkeveld shales. Onset of heavy ripping conditions for rock excavation at approximately 1.5m.

Excavation conditions for trenches will require heavy ripping with a large hydraulic excavator. In general the siltstones and mudstones are rippable, while the hard sandstone bands and areas of ferricrete may require the use of hydraulic hammers.
