Wild Landscaping

9 June 2015

BOTANICAL INVESTIGATION, ESKOM NEW POWER LINE, MELKHOUT TO DIEPREVIER

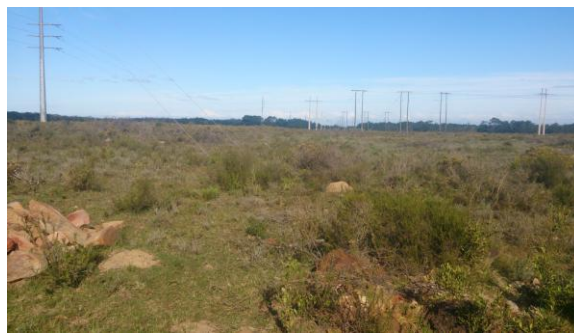
This area falls mostly within the boundaries of the Kouga municipality and consists of grassland and severely infected wattle vegetation (*Acacia mearnsii* and *Acacia saligna*) Around the Melkhout substation, transformed Fynbos is present, although during the time of our survey, no protected plant species were found.

Area around Melkhout substation

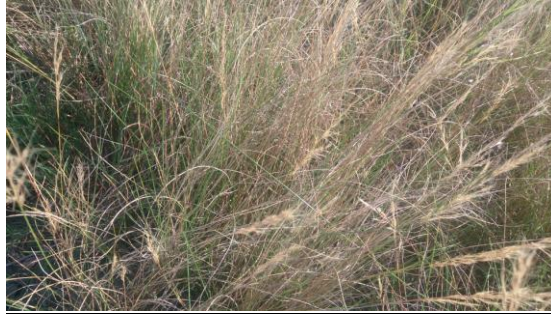
Vegetation here is predominantly pasture land which is periodically ploughed and seeded with grass species.
No protected plant species were found here.

Agricultural grassland

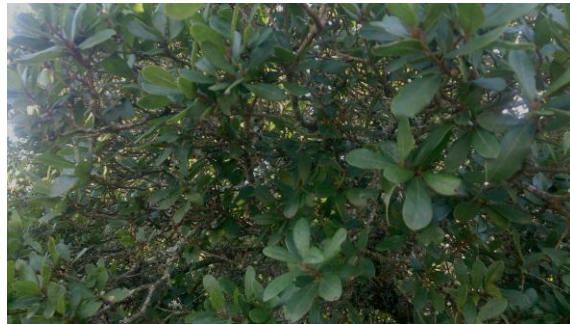
Drainage lines consist of narrow sections of pristine vegetation, the main tree species being *Searsia (Rhus) crenata* and *Searsia chirindensis*, *Pittosporum viridiflorum*, *Tarchonanthus camphoratus* and *Curtusia dentata*.

Pittosporum viridiflorum

As no pylons are to be constructed directly in any drainage lines, there are no species to be rescued here. However *Curtusia dentata* and *Pittosporum viridiflorum* are protected plant species and care must be taken to avoid any damage to these areas. It is recommended that these trees be clearly marked to prevent damage or destruction.

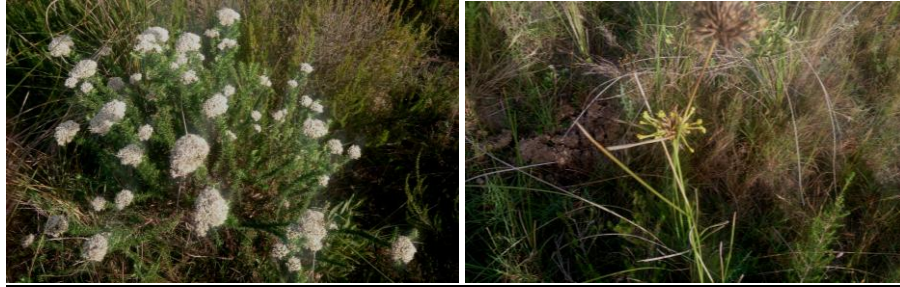
Fynbos consist of mostly pioneer plant species: *Stoebe plumosa*, *Bobartia orientalis*, *Erica sessilifolia*, *Erica curvifolia*, and various grasses.

Metalasia and Bobartia orientalis

Although no protected plant species are present within proposed construction boundaries, vegetation here could be rescued for rehabilitation purposes at the end of the project.

Topsoil stripped during the construction process should be stockpiled for re-use during rehabilitation. Care should be taken to prevent invasive plant species from establishing in the topsoil.

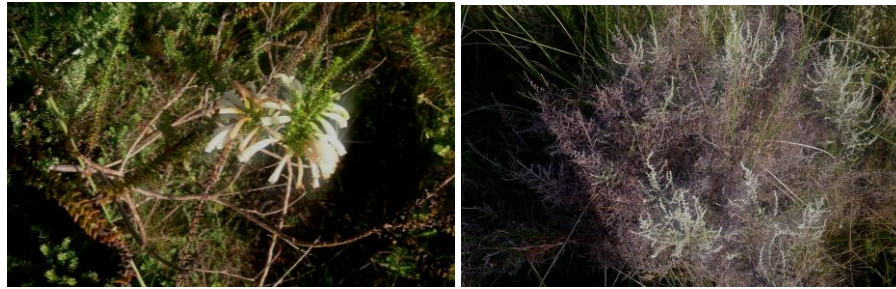
Erica and Stoebe

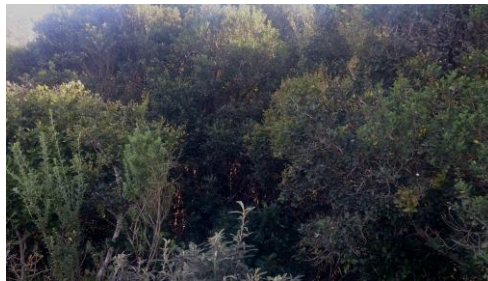
No protected plant species were found within proposed construction boundaries. However there are 2 small natural forests near pylon 75 which contain species of *Pittosporum viridiflorum*. As they are not close to the actual construction site, removal will not be necessary. We would however recommend that they be clearly marked to prevent damage or destruction.

Forest species in drainage areas

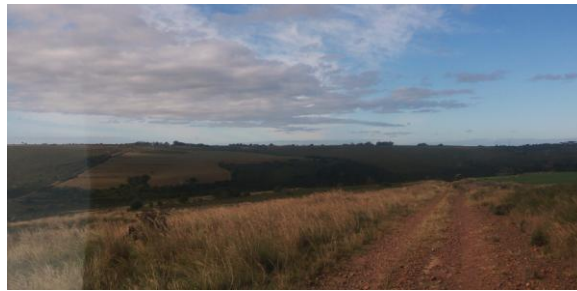
This section travels over farmland consisting of grasses with occasional Fynbos species. No protected plant species were found here.

Agricultural farmland

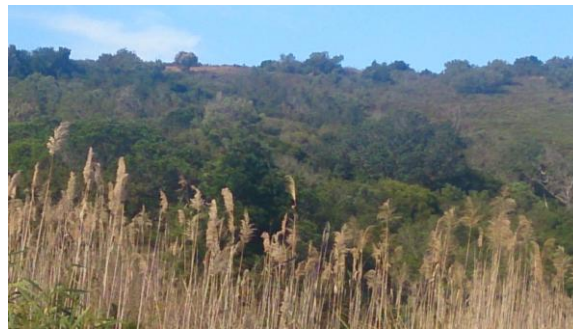
The proposed line crosses over a river containing various tree species. Although many of the trees are invasive, one species of *Podocarpus falcatus* was present in the river bed, with a few specimens of *Pittosporum viridiflorum*, both of which are protected. Construction is not expected to take place here, but care must be taken not to damage or destroy natural tree species. We would recommend that these trees be marked to prevent damage or destruction.

River section
