Plates

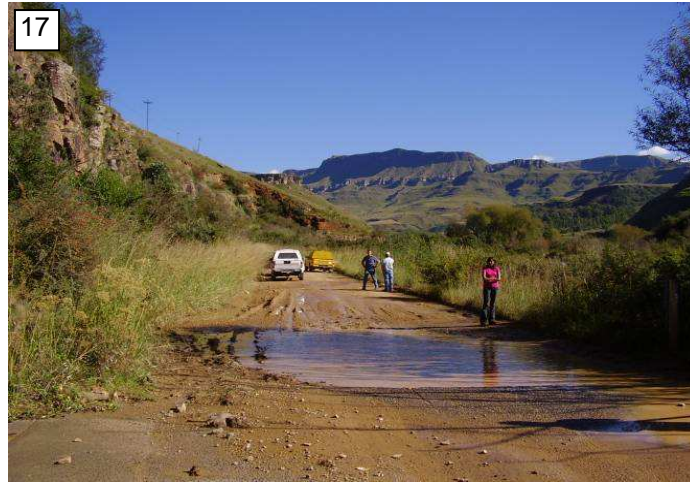
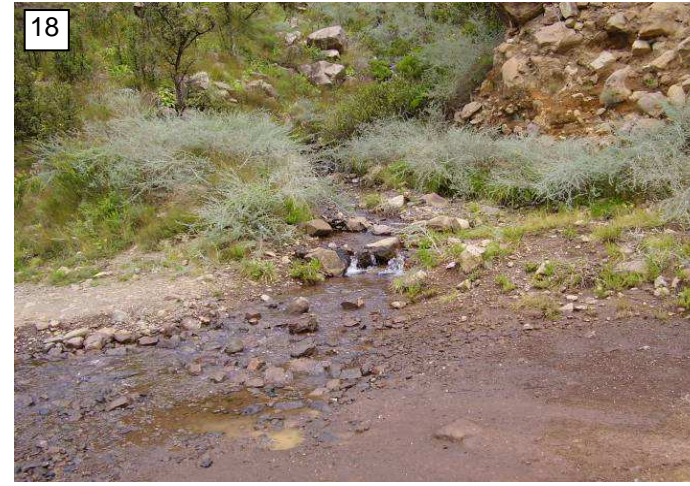
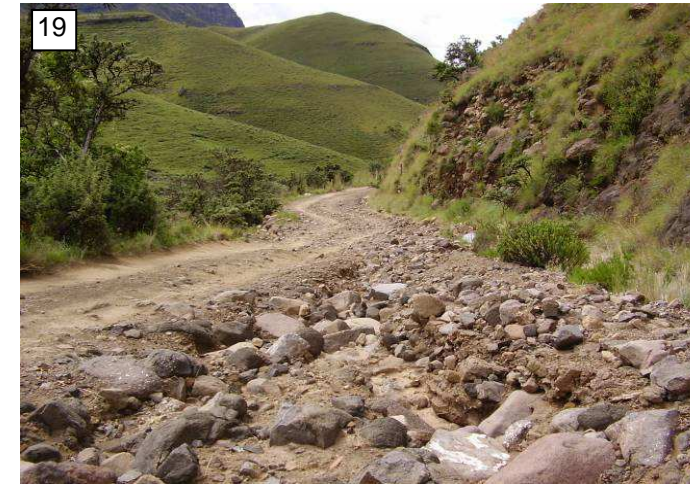
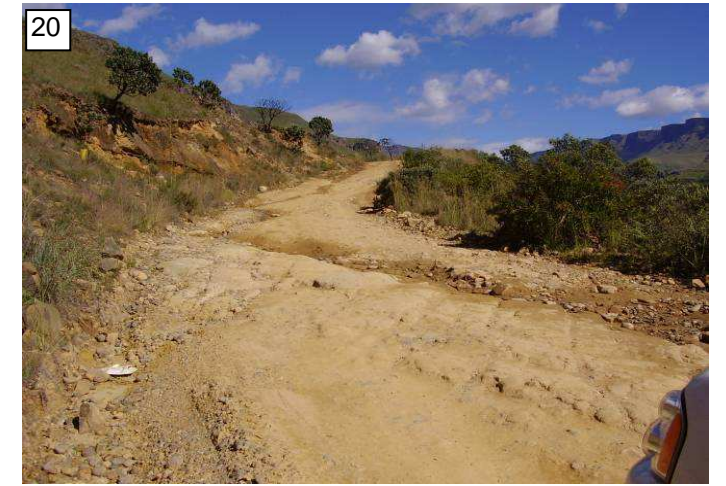
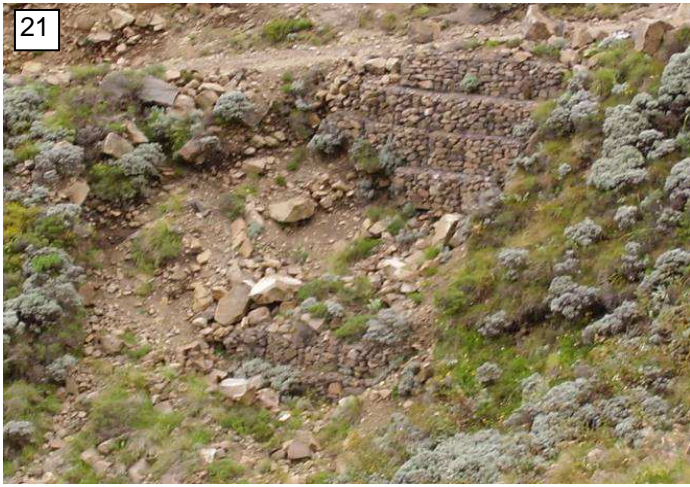
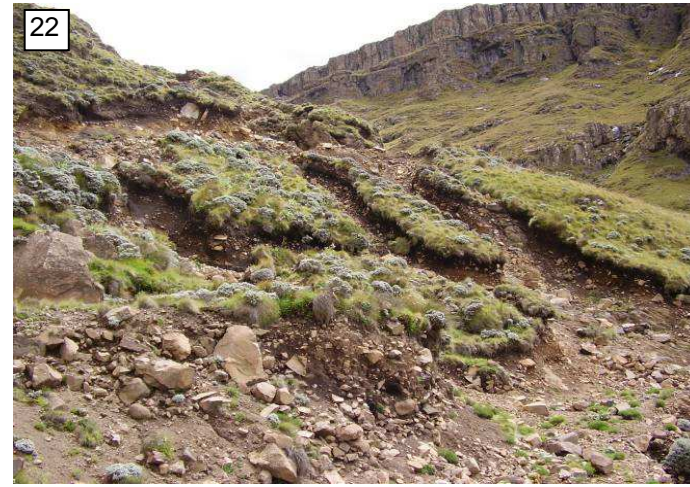
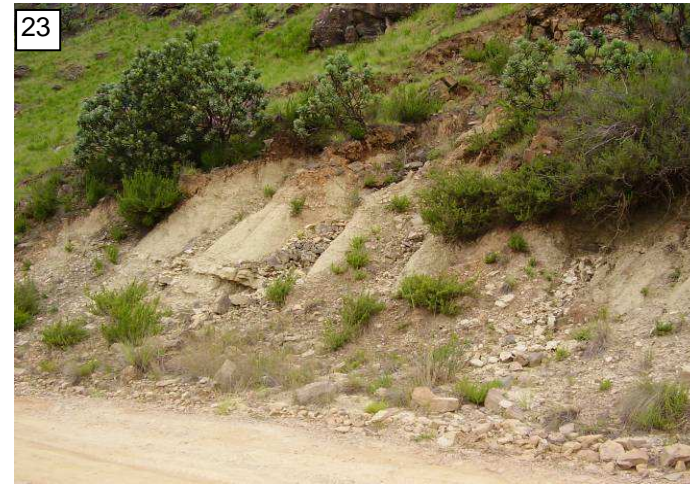
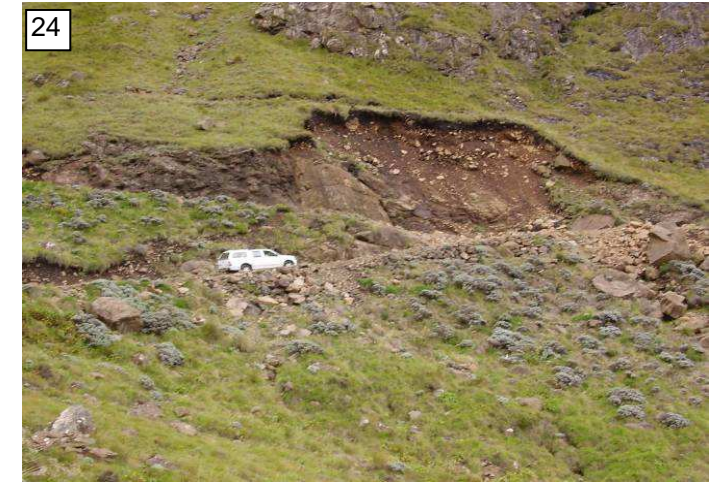
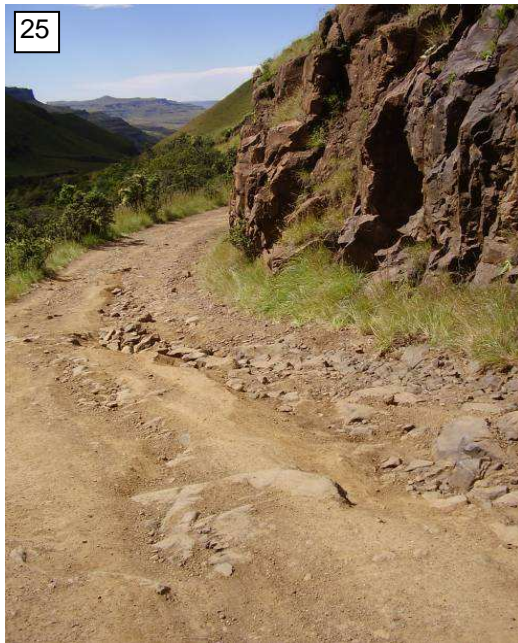
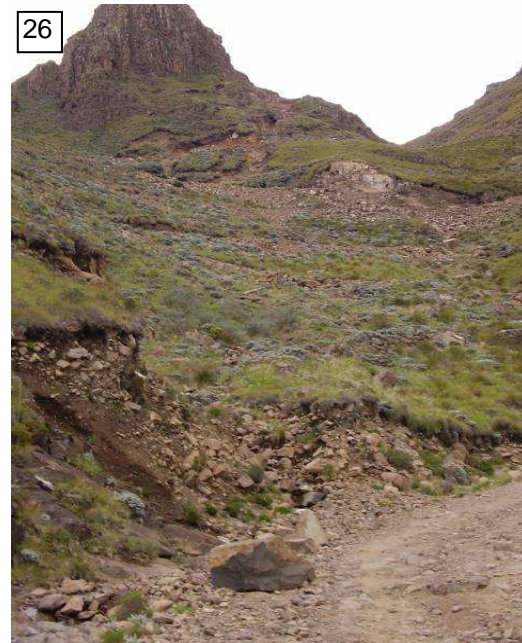
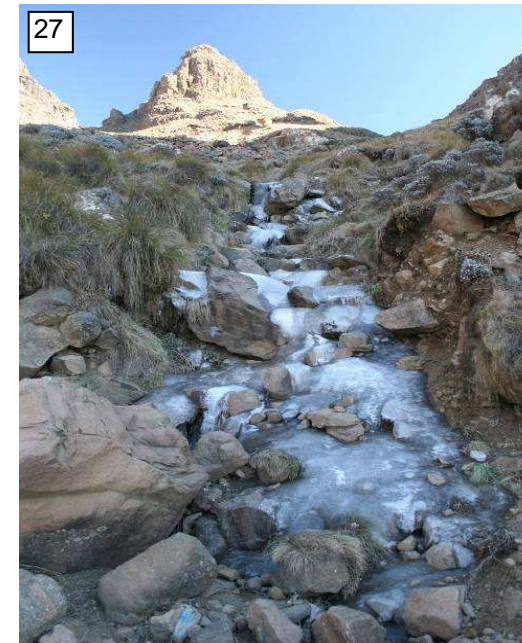
- 17 standing water on the road destabilises the road
- 18 streams crossing over the road scour the road
- 19 erosion from river bank collapse resulting in flow down the side of the road causing further longitudinal erosion
- 20 erosion from uncontrolled stream flow across the road
- 21 collapsed river side bank and failure of support structure
- 22 heavily eroded banks alongside the road
- 23 eroded cut-away banks
- 24 collapsed bank alongside the road
- 25 eroded section of the road due to erosion and vehicle use
- 26 significant erosion and collapse of outer banks of switchbacks
- 27 erosion at the switchbacks due to ice cracking
